**SAMPLING ACTIVITIES REPORT  
for a  
COMBINED SITE INSPECTION and REMOVAL ASSESSMENT

SMURFIT-STONE MILL  
Near Missoula, Missoula County, Montana**

**TDD Nos. 1105-09 and 1109-07**

**December 19, 2011**

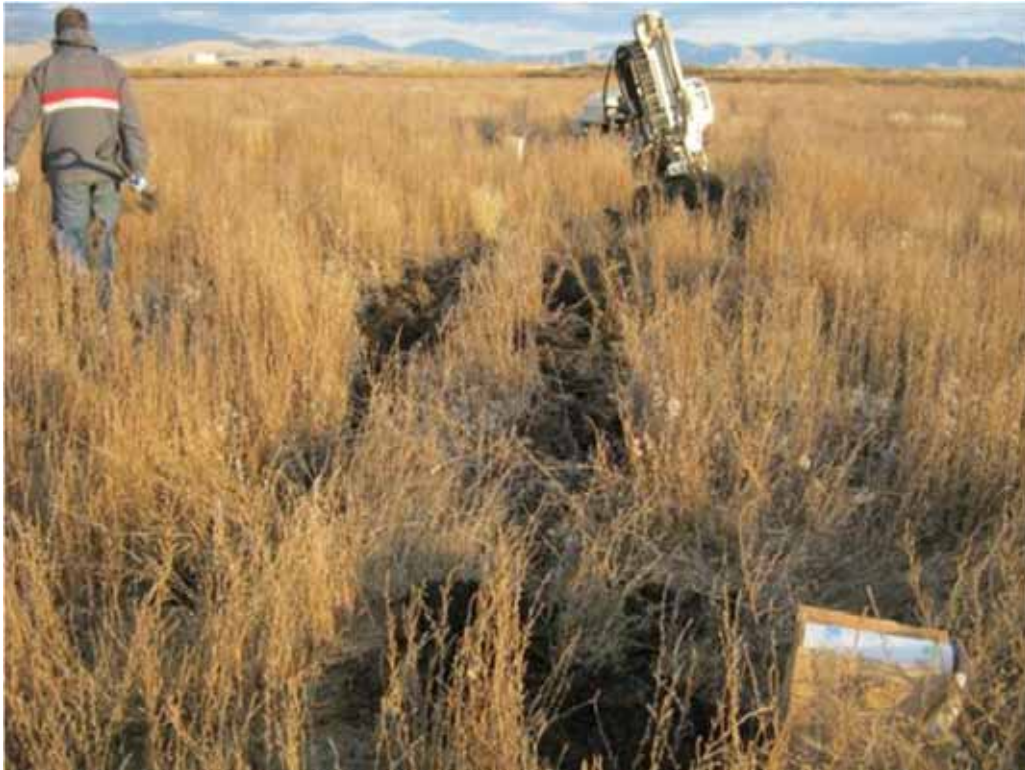
**Photo 1**

Geoprobe® stuck in Sludge Pond 4 due to soft surface. John Noto (UOS) on left.  
Looking east.

- Subsurface soil samples SSSO10xx (Sludge Pond 5), SSSO12xx (Sludge Pond 4), and SSSO14xx (Emergency Spill Pond, wet cell); and Geoprobe<sup>®</sup> groundwater samples SSGW06 (Sludge Pond 4) and SSGW09 (Emergency Spill Pond wet cell) were not collected as the track-mounted Geoprobe<sup>®</sup> could not safely access these proposed sampling locations due to a soft surface (Photo 1).

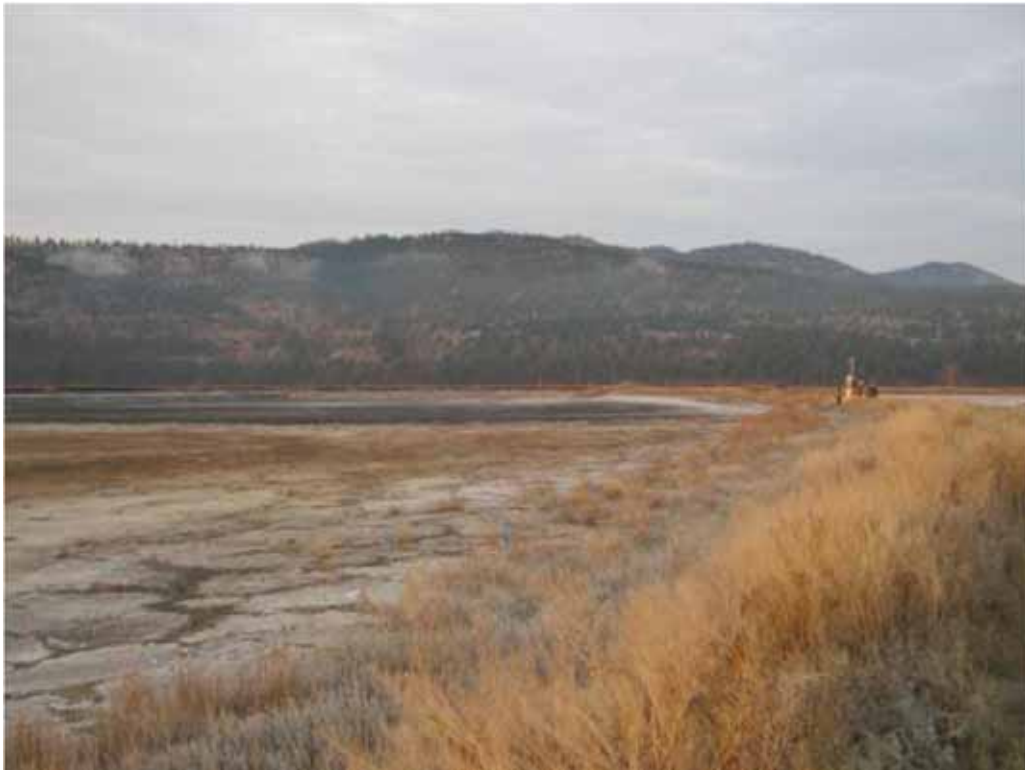
**Photo 2**

Geoprobe® at location SSGW07 on berm between sludge ponds 4 (far right) and 5  
(left). Looking west.

- Geoprobe<sup>®</sup> groundwater sampling location SSGW07 was moved from within Sludge Pond 5 to a location on the berm between Sludge Ponds 4 and 5, due to the lack of safe access for the Geoprobe<sup>®</sup> to the proposed sampling location (Photo 2).

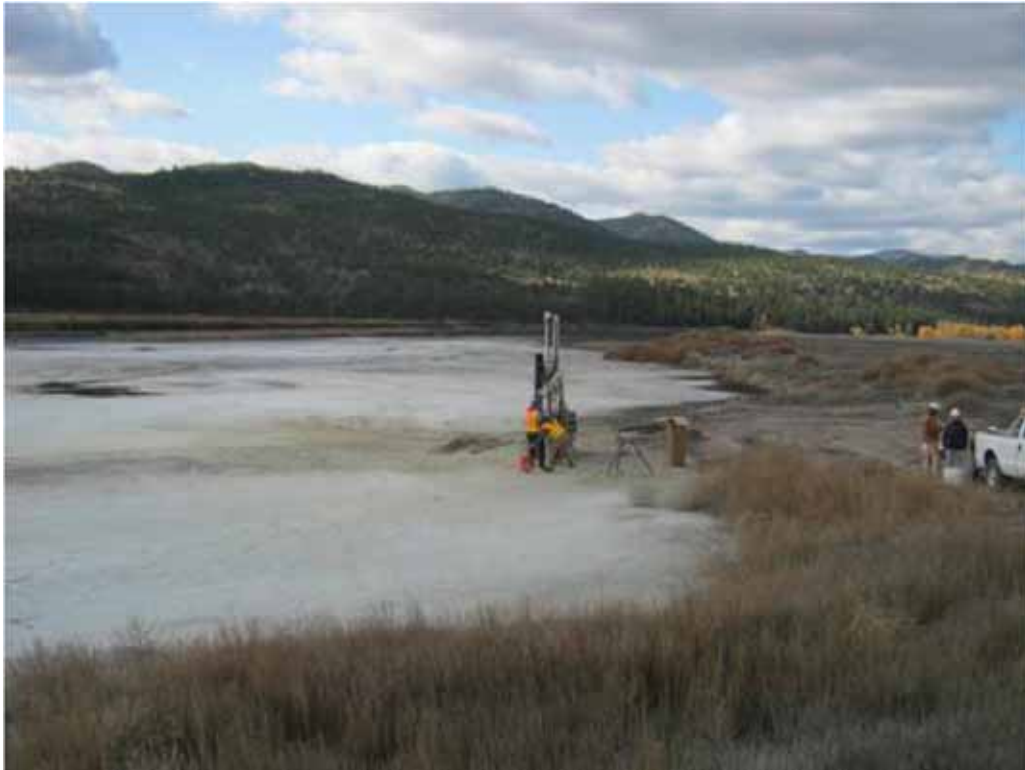
**Photo 3**

SSSO09 source sample location at edge of Sludge Pond 5. Looking northwest.

- Subsurface soil sampling locations SSSO11xx (Sludge Pond 4) and SSSO09xx (Sludge Pond 5) were moved from the center of each pond to the edge, due to the lack of safe access for the Geoprobe<sup>®</sup> to the proposed sampling locations (Photo 3).

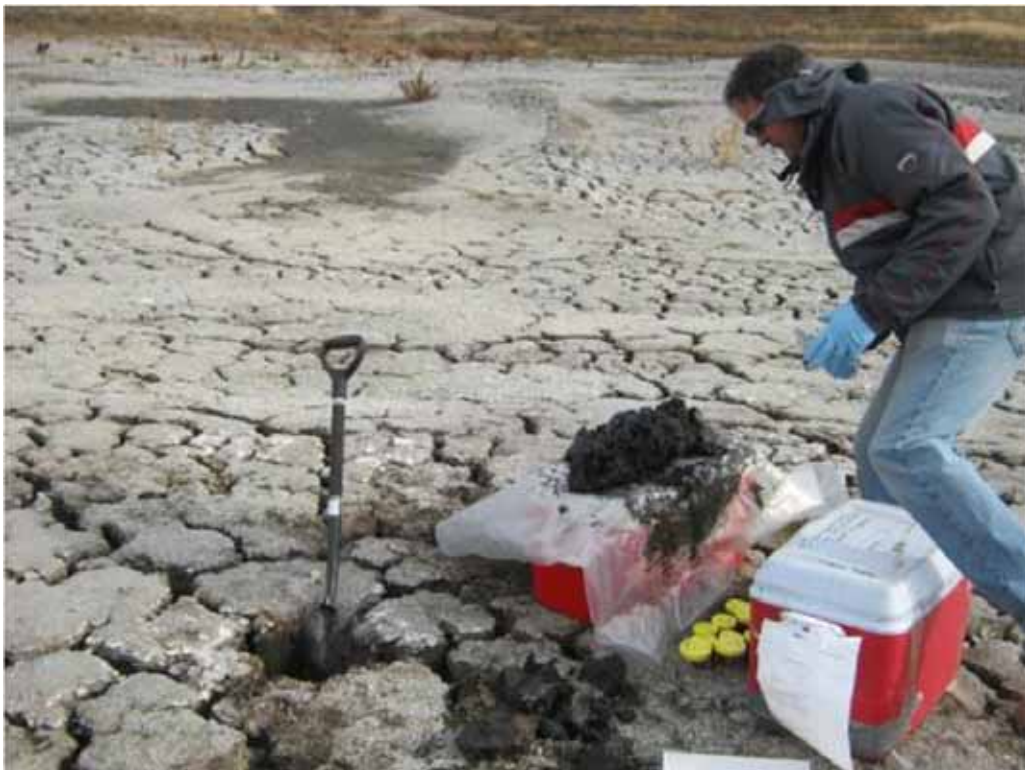
**Photo 4**

John Noto (UOS) collecting surface soil/ source sample SSSO1402 at northern end of Emergency Spill Pond. Looking east.

- Surface soil samples SSSO0702, SSSO1002, SSSO1202, and SSSO1402 were collected directly from the surface of ponds with disposable plastic scoops, rather than from Geoprobe<sup>®</sup> macro-core sleeves, due to the lack of safe access for the Geoprobe<sup>®</sup> to the proposed sampling locations (Photo 4).

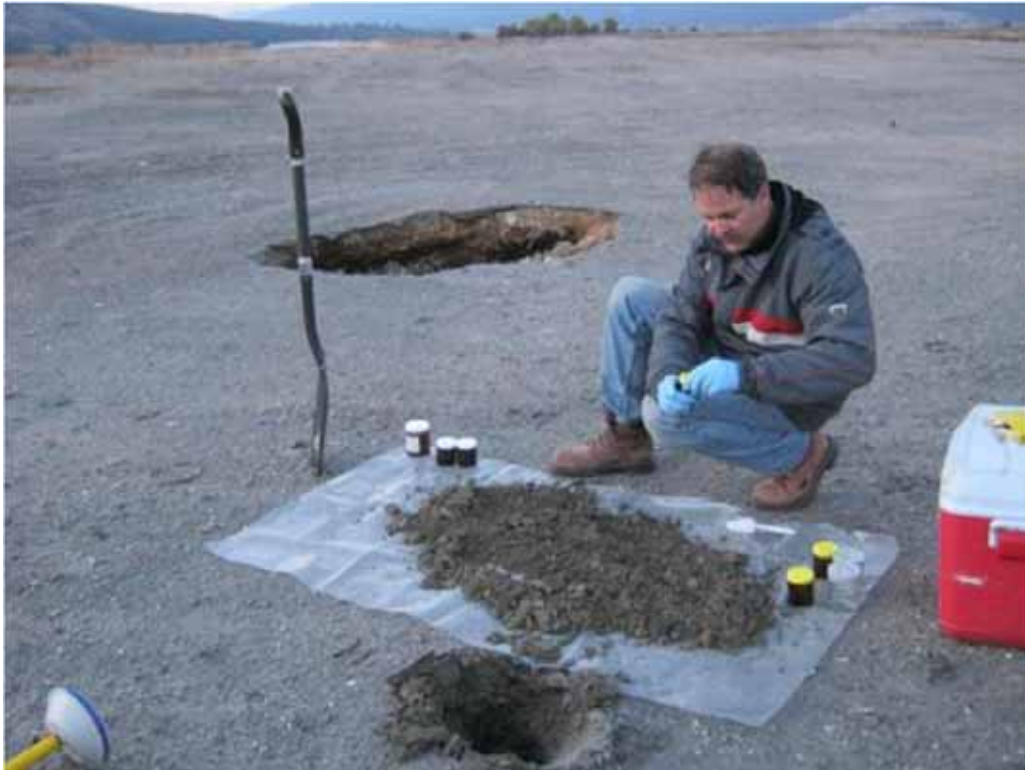
**Photo 5**

John Noto (UOS) collecting SSSO1702 opportunity surface soil/ source sample from area of possible sludge adjacent to Landfill A. Note sinkhole in background and lack of cover. Looking north.

- Opportunity sample SSSO1702 was added to the sample plan, being collected from an area of what appeared to be exposed soil/sludge adjacent to Landfill A (Photo 5).

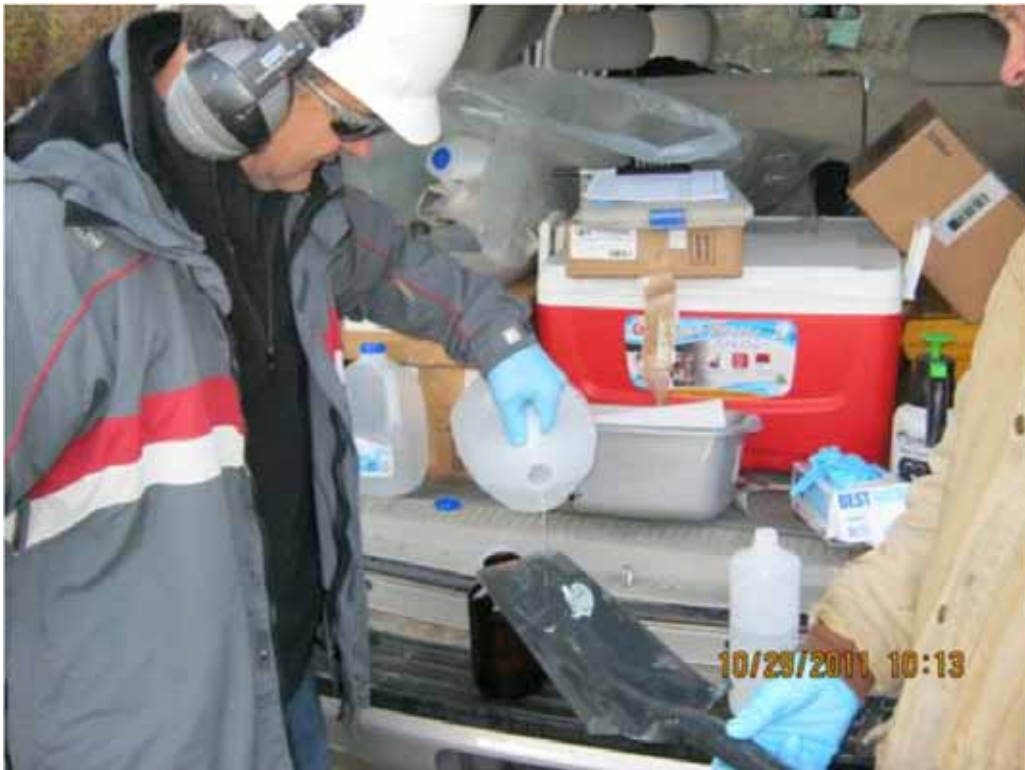
**Photo 6**

John Noto (left) and Jeff Miller (right)(both UOS) collecting rinsate sample SSSW89 from shovel used to collect some surface soil samples.

A steel shovel was sometimes needed to assist in the collection of source samples, due to the viscous nature of the material and the desire to collect material to a depth of 2 feet bgs. The shovel was decontaminated prior to its initial use and then between sampling locations as per the UOS Technical Standard Operating Procedure (TSOP) 4.11 “Equipment Decontamination” (UOS 2005). The same stainless steel cutting shoe was used for each Geoprobe® source and groundwater location. The cutting shoe is the only reusable part of the sampling system that makes contact with in situ soils. The drilling subcontractor, MSE Technology Application, Inc., decontaminated the cutting shoe prior to its initial use and then between sampling locations using a method equivalent to that in UOS TSOP 4.11. A rinsate blank (sample SSSW89) was collected from both the shovel and the cutting shoe to assess the quality and thoroughness of the decontaminating procedures used (Photo 6).

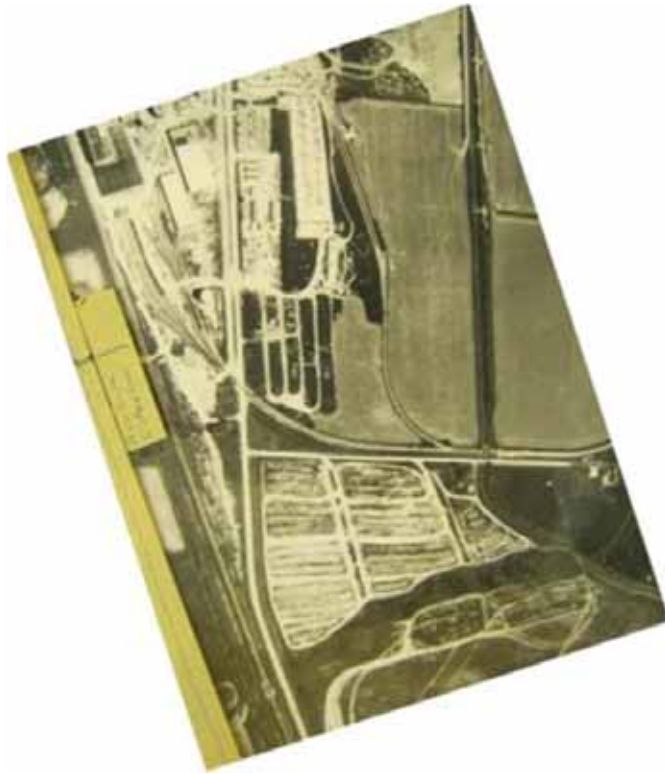
**Photo 7**

Aerial photo (undated) showing former landfarm area (area with linear piles in bottom half of photo).

Field screening of soils with immunoassay test kits was proposed for the landfarm area if visual evidence of contamination was not observed. The test kits were not used as an aerial photo was found that showed the entire land parcel had been used for landfarming (Photo 7), and specific areas devoid of vegetation were noted in the field (Photo 8).

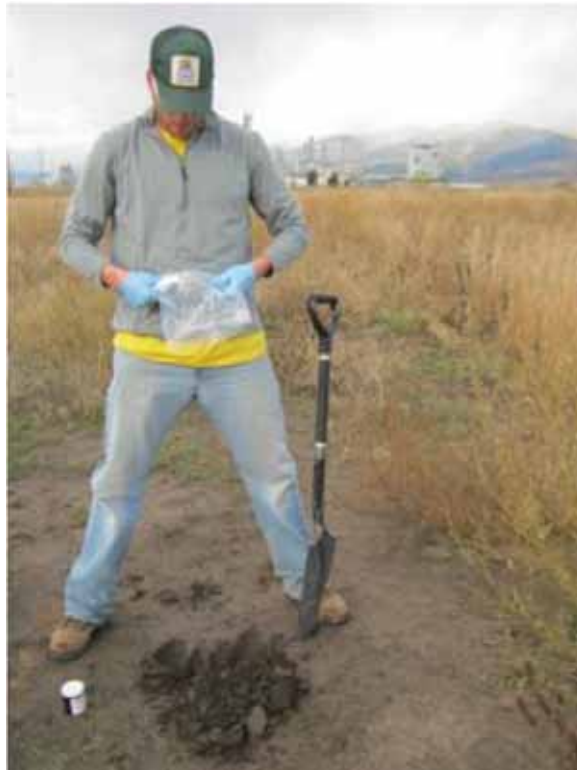
**Photo 8**

Jeremiah Ervin (UOS) collecting asbestos sample SSSO0302 from unvegetated area within former landfarm area. Looking north.

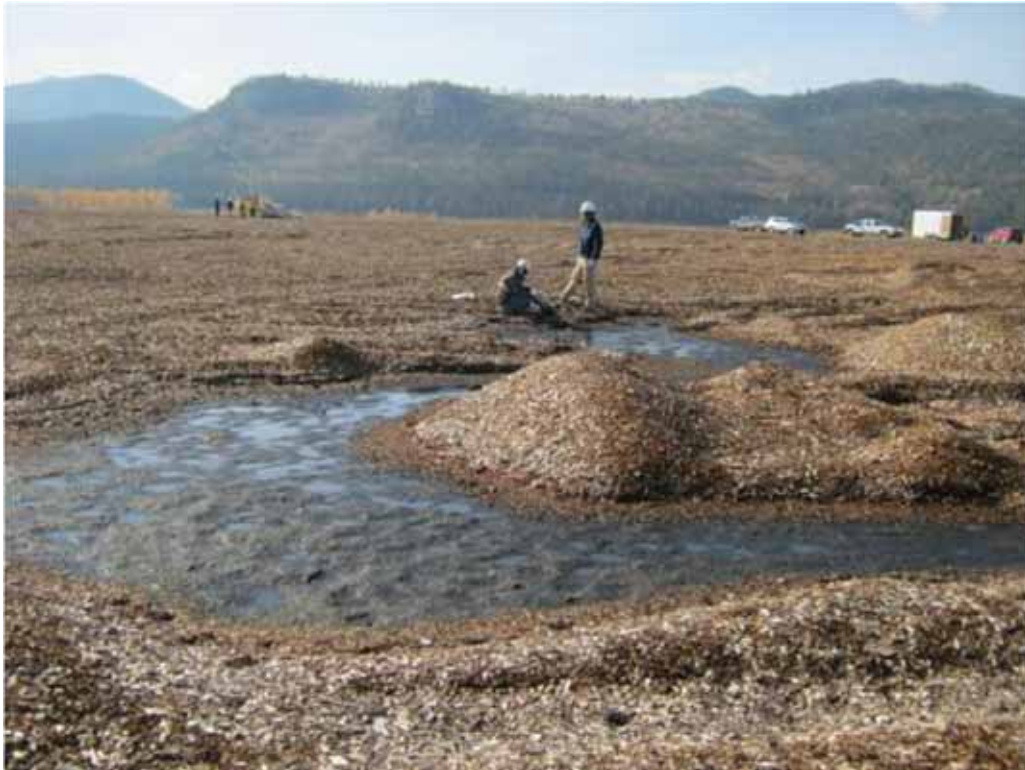
**Photo 9**

Wood chip covering over Sludge Pond 3. John Noto (UOS) and Carlo Arendt (Hydrometrics, Inc.) collecting SSSO0702 source sample in background. Looking southwest.

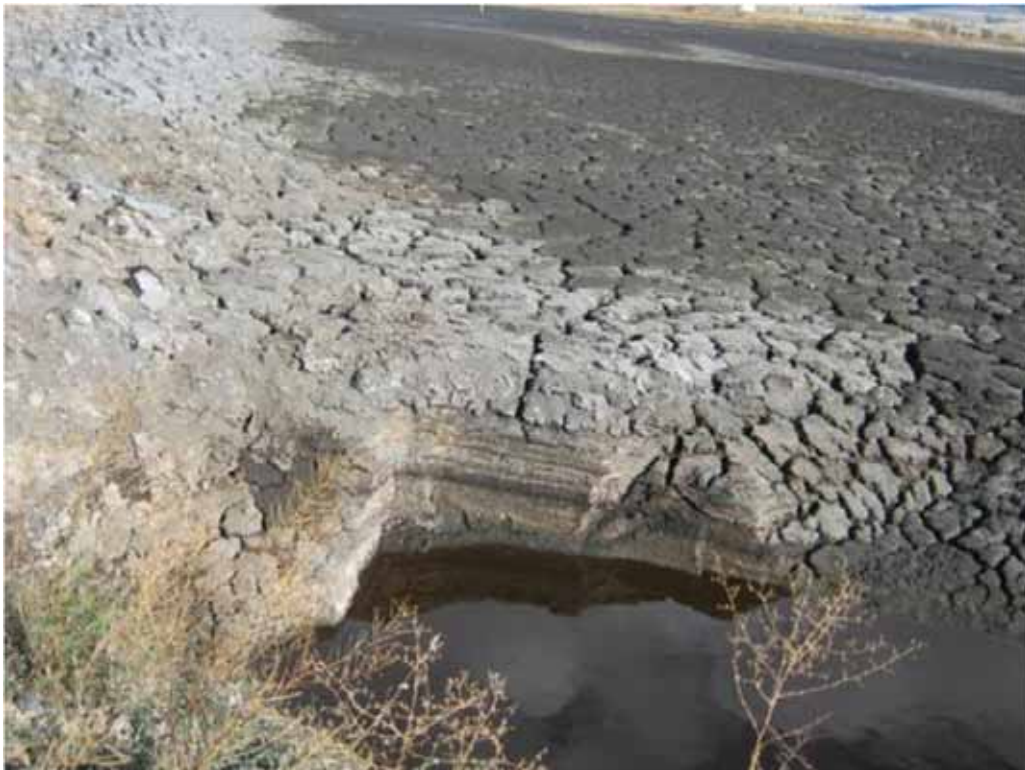
**Photo 10**

Northern berm of Sludge Pond 4 showing layering of sludge, standing water, and lack of cover. Looking east.

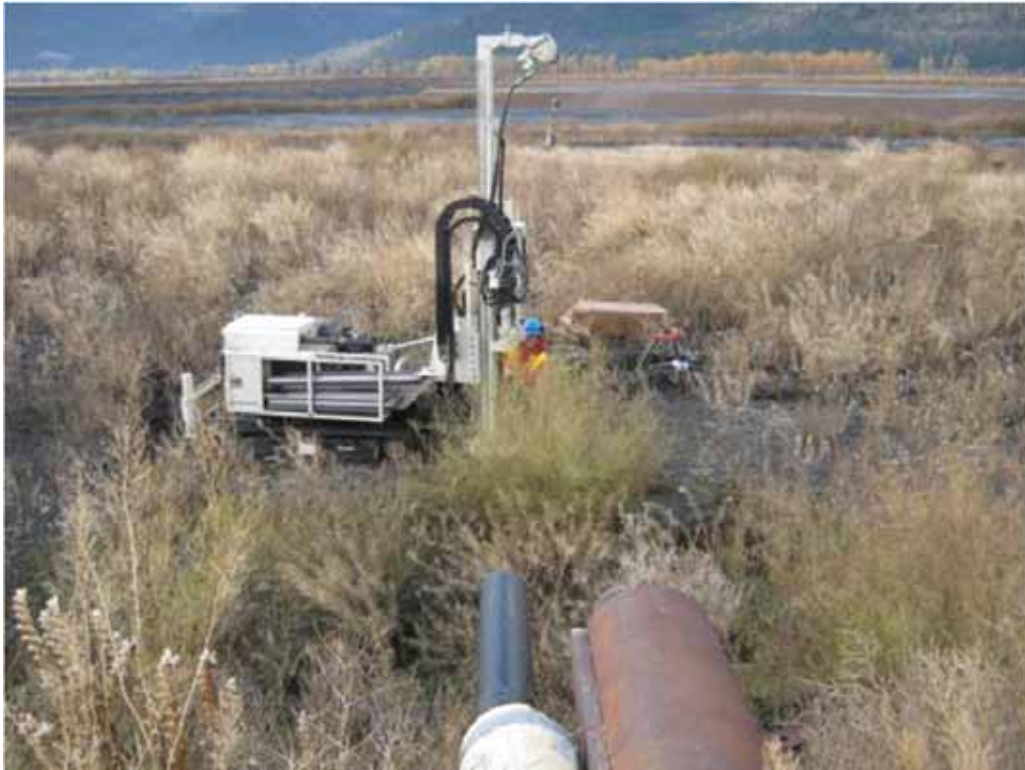
**Photo 11**

Geoprobe® at sample location SSSO0514 within Sludge Pond 17. Photo shows sparse vegetation and pond infall in foreground. Looking southwest.

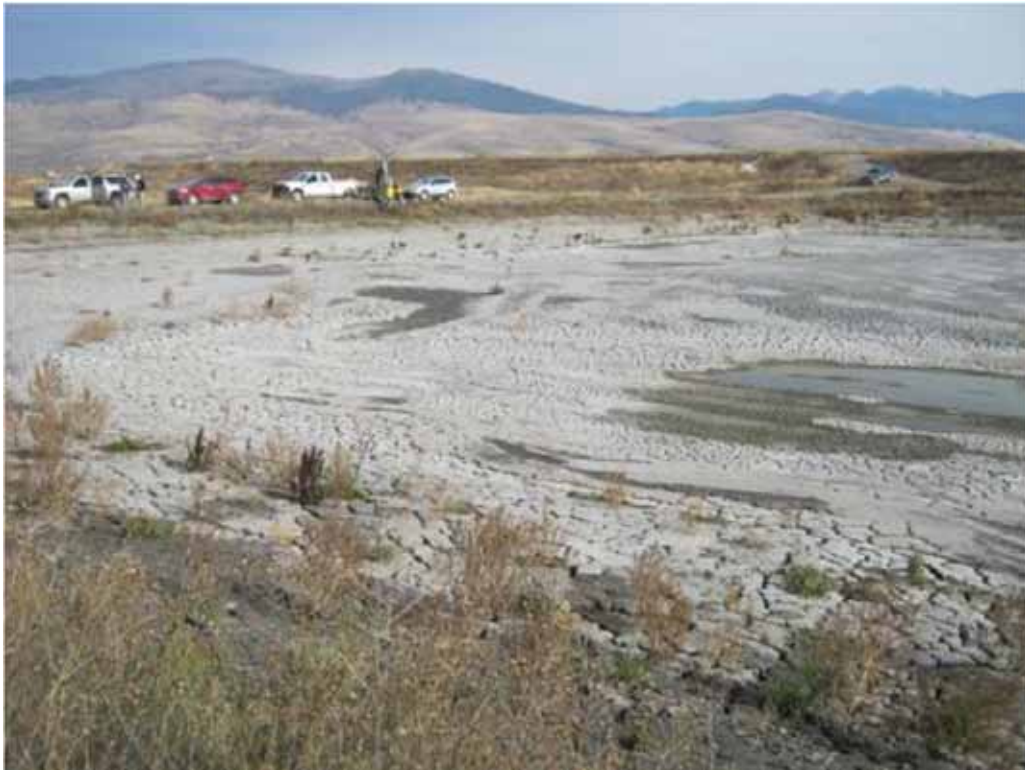
**Photo 12**

Northern end of Emergency Spill Pond wet cell showing standing water and lack of cover. Geoprobe® is at location SSGW11 on northern berm of pond. Looking northeast.

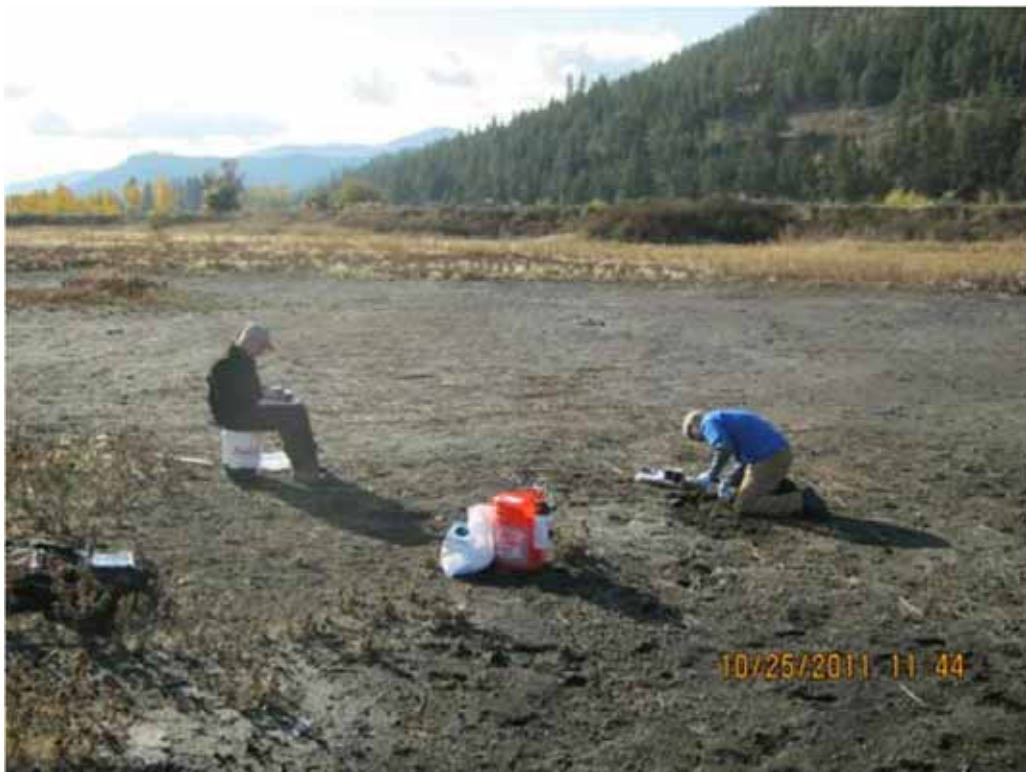
**Photo 13**

Scott Mason (Hydrometrics, left) and Jeff Miller (UOS, right) collecting surface soil/ source sample SSSO1602 from Wastewater Pond 2. Note sparse vegetation and lack of cover. Looking south.

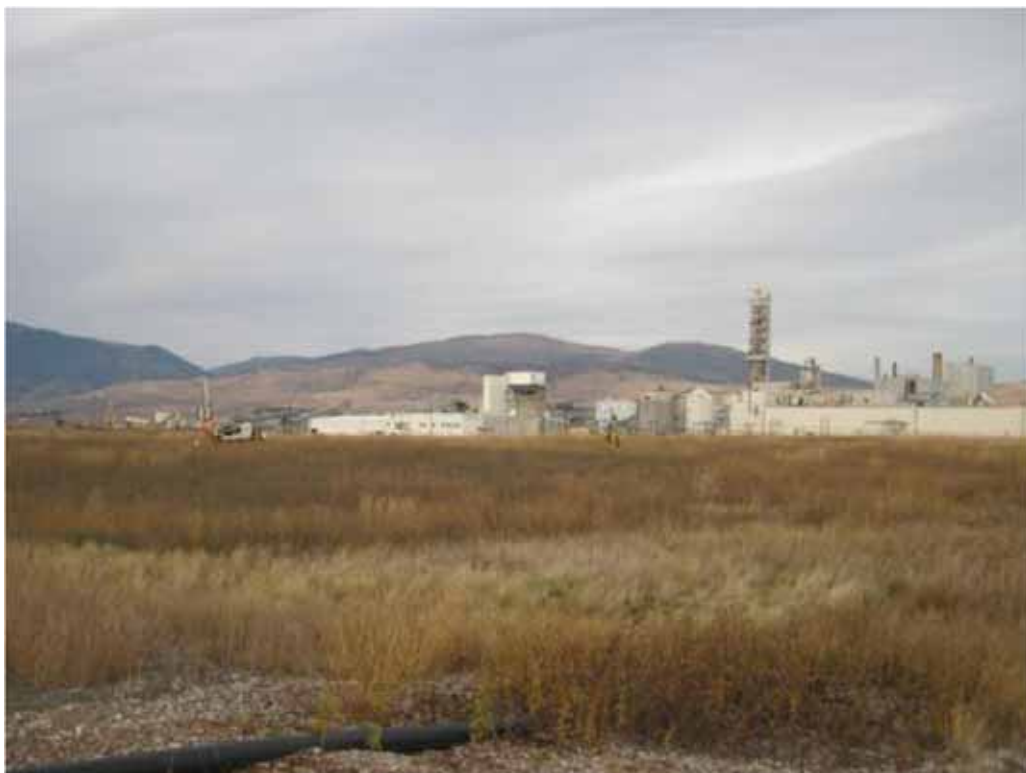
**Photo 14**

Geoprobe® on top of Landfill A at SSGW05 location. Note vegetative cover. Looking northeast.

Source Name	Source Type (per HRS)	Surface Area* (acres)	Average Depth* (feet bgs)	Volume* (acre feet)	Depth Observed with Geoprobe® feet bgs)	Cover Present?	Liner Present?	Leachate Collection System Present?	Run-on/ Run-off Controls Present?
Sludge Pond 3	Backfilled Surface Impoundment	20	8	160	16	Yes (wood chips only), cover not complete (Photo 9)	No	No	No
Sludge Pond 4	Surface Impoundment	23	10	230	6.5-8	No, some vegetation (Photo 10)	No	No	No
Sludge Pond 5	Surface Impoundment	24	14	336	16.5	No, some vegetation (Photos 2, 3)	No	No	No
Sludge Pond 17	Surface Impoundment	24	7.2	173	12-13.5	No, some vegetation (Photo 11)	No	No	No
Emergency Spill Pond (Pond 8)	Surface Impoundment	24	5	120	5.6 in dry cell	No, some vegetation (Photo 12)	No	No	No
Pond 2	Surface Impoundment	121	11.7	1414	NA	No, some vegetation (Photo 13)	No	No	No
Landfill A	Landfill	11	NA	NA	NA	Yes, 18” clay, vegetation (Photo 14)	No	No	No

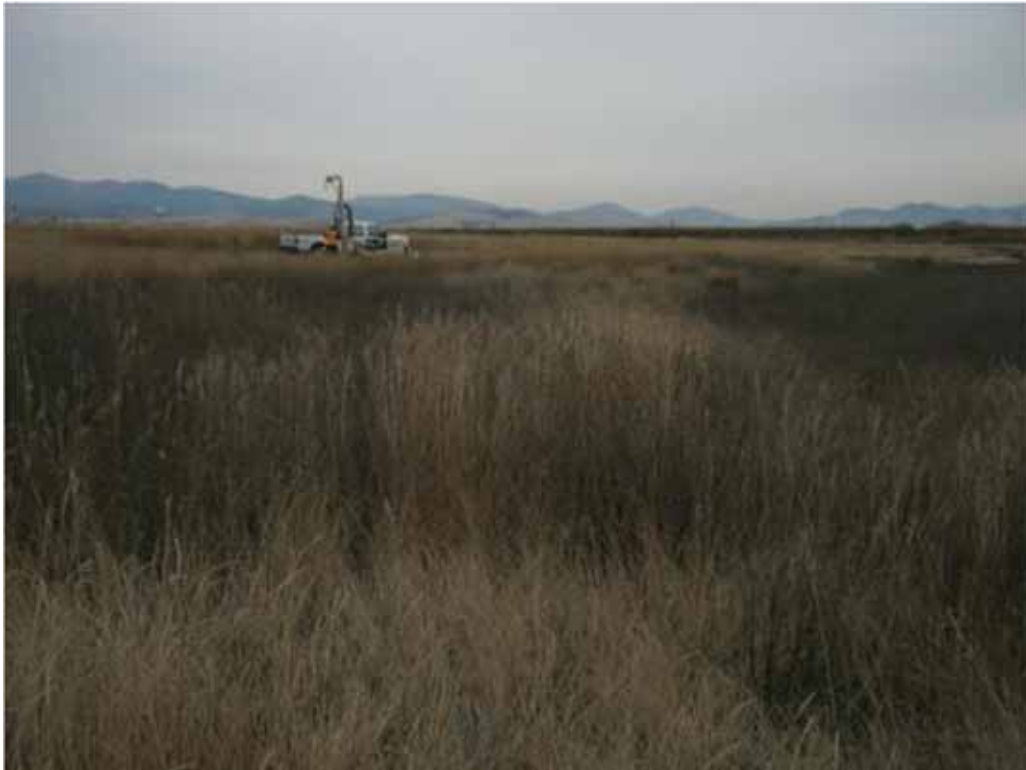
**Photo 15**

Geoprobe® on top of Landfill 6 (edge of landfill is roughly marked by the lighter vegetation in the distance) at SSGW08 location. Note vegetative cover. Looking north.

Landfill 6	Landfill	16	6.1	97	NA	Yes, 18” clay, vegetation (Photo 15)	No	No	No
Landfill G	Landfill	4	NA	NA	NA	Yes, 18” clay, vegetation (Photo 16)	No	No	No
Former landfarm	Landfarm	36	NA	NA	NA	No, largely vegetated (Photo 8)	No	No	No
Pile near Landfill A	Pile, other	1.95§	NA	NA	NA	No, unvegetated (Photo 5)	No	No	No

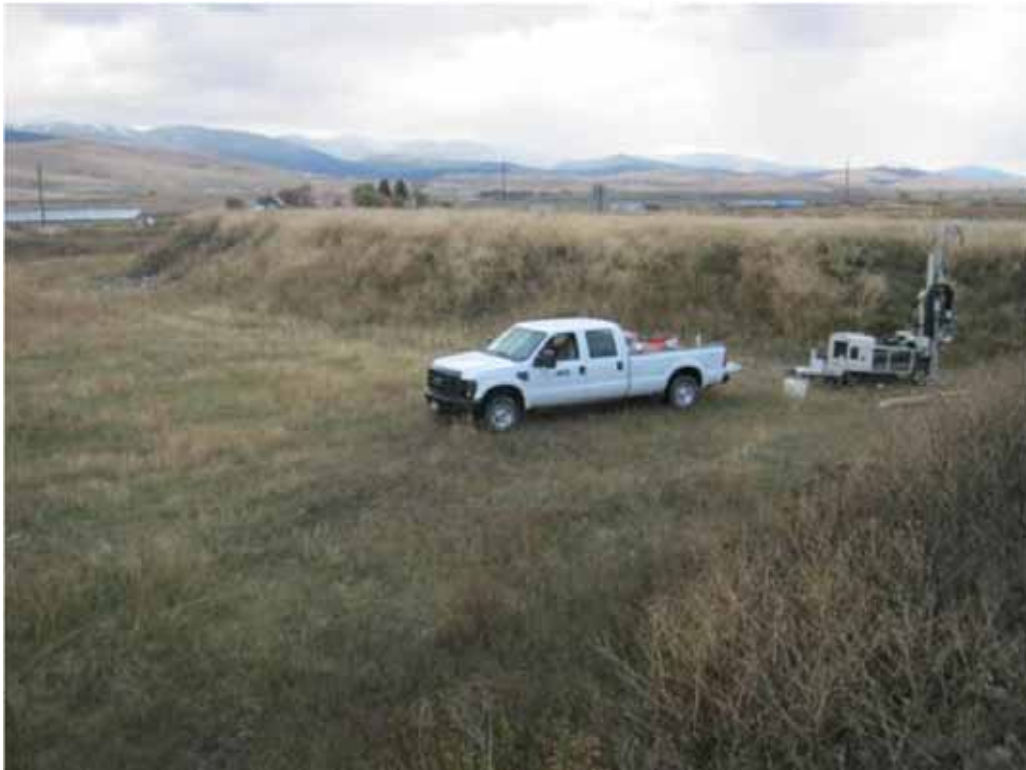
**Photo 16**

Geoprobe® at northwest corner of Landfill G (raised area in background) at SSGW12 location. Note vegetative cover. Looking east.

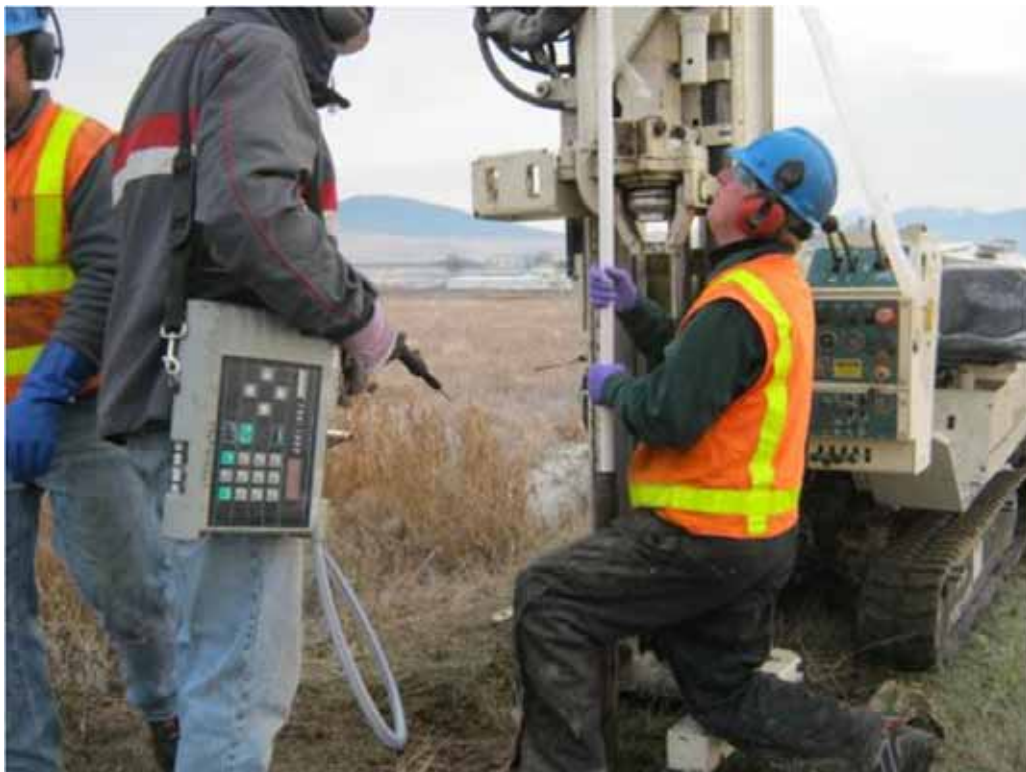
**Photo 17**

John Noto (UOS) conducting air monitoring of the breathing zone during installation of SSGW07. Ken Manchester (MSE Technology Applications, Inc.) on right. Looking northeast.

It should be noted that high concentrations of hydrogen sulfide and methane gases were observed being released from boreholes and groundwater monitoring wells installed within all four sludge ponds, and to a lesser degree at all three landfills. Due to safety concerns, UOS began monitoring the ambient air quality in the breathing zone utilizing a TVA-1000 photoionization detector/flame ionization detector (PID/FID) and a MultiRAE H<sub>2</sub>S gas monitor at each borehole/groundwater well location during installation and sampling activities (Photo 17).

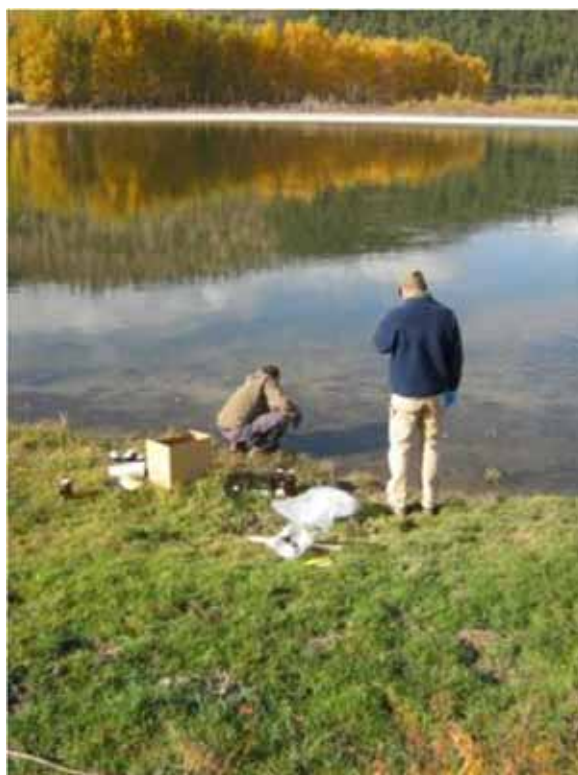
**Photo 18**

Photo showing USFWS-identified wetlands on an island across the Clark Fork River (far background). UOS was unable to access these wetlands during the assessment. John Noto (UOS) and Carlo Arendt (Hydrometrics) in foreground collecting surface water sample SSSW09. Looking west.

The occurrence of HRS-eligible wetlands within the Clark Fork River drainage could not be confirmed on the ground. The U.S. Fish and Wildlife Service National Wetlands Inventory identifies two palustrine scrub-shrub wetlands (of 0.13 mile and 0.34 mile in length) occurring within an island complex due west of Pond 13A (USFWS 2011). These wetlands were inaccessible during the field event and could not be easily ascertained from the eastern shore of the river (Photo 18, Figure 2).

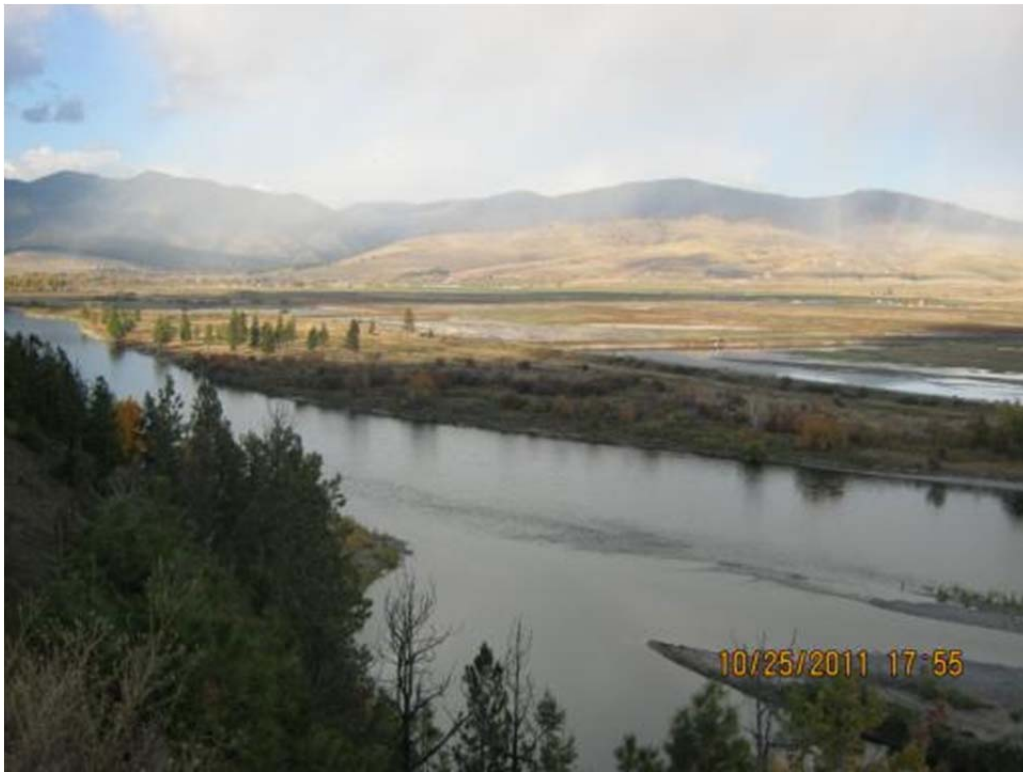
**Photo 19**

Evidence of recreation (tire tracks beneath date stamp) on sand bar within Clark Fork River, adjacent to Pond 11. The remains of a camp fire are off the picture to the right. Looking northeast.

Although the stretch of river adjacent to the mill site is considered a fishery with a Montana Fish, Wildlife and Parks (MFWP) fishery resource value of 1 (Outstanding) (MFWP 2011), no fisherman were observed during the field activities. This may simply have been due to the season (late fall) and timing of the field work (mostly weekdays). Two MFWP fishing access sites are located in the vicinity of the site (approximately 0.5 mile upstream of the southern mill site boundary, and beginning approximately 2.5 miles downstream of the mill site), but neither site was visited during the field activities. The only evidence of recreation on the stretch of the river adjacent to the mill noted during the field work was tire tracks and the remains of a campfire on a sand bar west of Pond 11 (Photo 19).
